Longwall Gate Road Stability in a Steeply Pitching Thick Coal Seam With a Weak Roof

Report of Investigations 9580

By Lance R. Barron and Matthew J. DeMarco

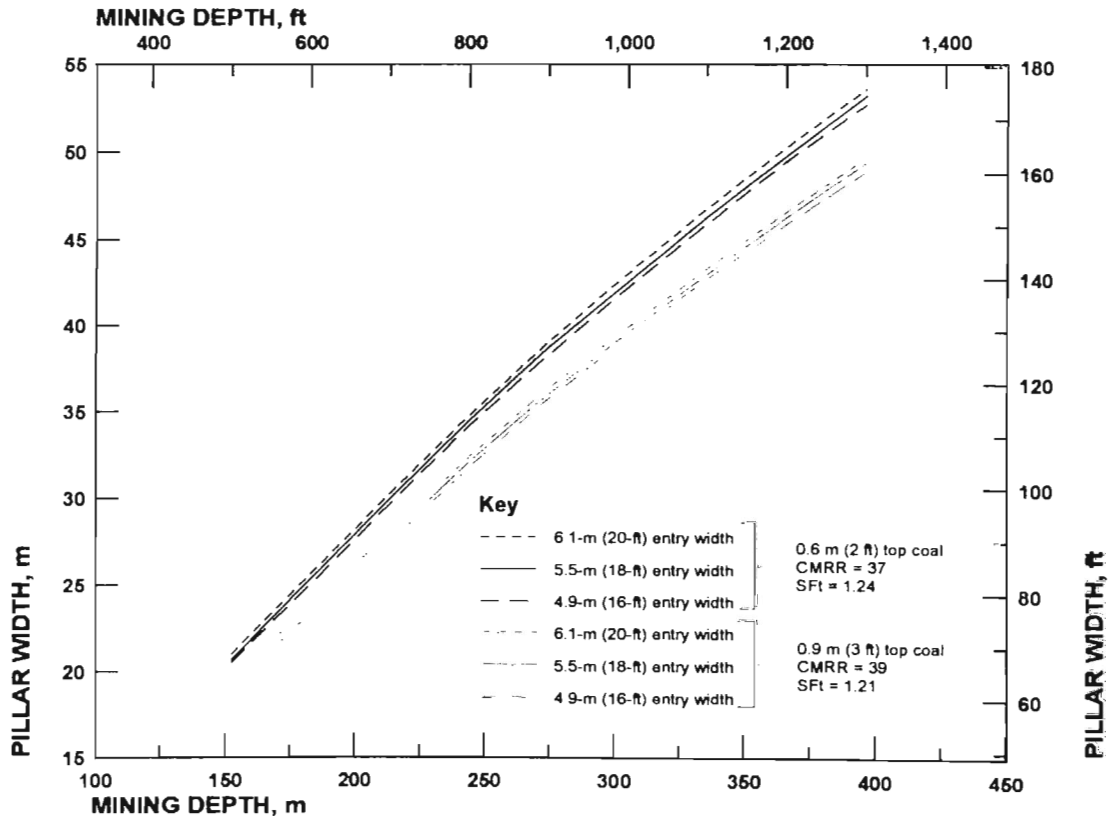
Figure 23

Results from ALPS-CMRR evaluation for effects of top coal thickness and entry width on two-entry gate road stability for Shoshone No. 1 Mine.
